# **KELVA** INVENTOR OF WEB CLEANING

**SPECIFIC SOLUTIONS  
FOR CORRUGATED BOARD.**

# WEB CLEANING FOR CORRUGATED APPLICATIONS / INSTALLATIONS

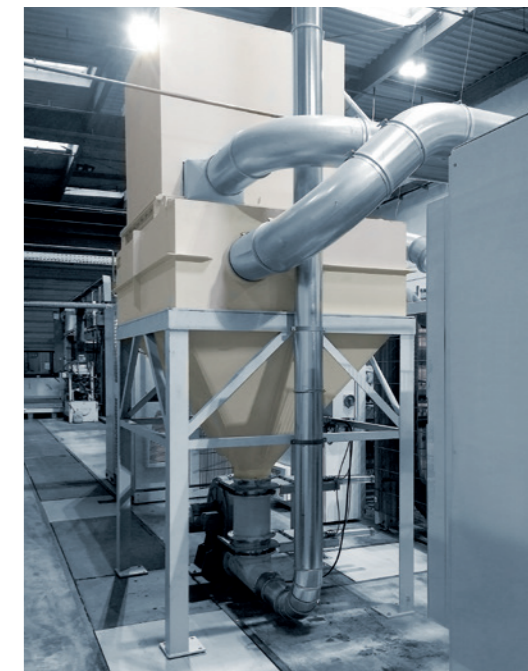
KELVA filter/fan unit AFF-I42 with waste handling connected to a central system

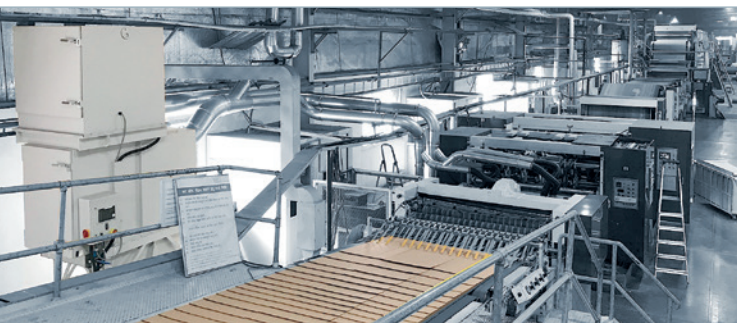
## KELVA Corrugated web cleaner

Overview of a KELVA installation on 2,8 m corrugator. Filter/fan unit model AFF-I68 connected to a ST85CC cleaner and additional exhausts.
